Minutes of a meeting of the board of directors held via  
Microsoft Teams on 17<sup>th</sup> September 2025 at 08:45hrs

# COUNTY GROUND STADIUM **ANNUAL STRUCTURES INSPECTION 2025**

Project name **County Ground Stadium Annual Structures Inspection 2025**  
Project no. **1620012351**  
Recipient **Swindon Town Football Club**  
Document type **Inspection Report**  
Version **01**  
Date **July 2025**  
Prepared by **Daniel Gonzalez-Fernandez – Engineer**  
Checked by **Nicholas Porter CEng MICE – Associate**  
Approved by **Paul Swainson CEng MICE MIStructE – Director**

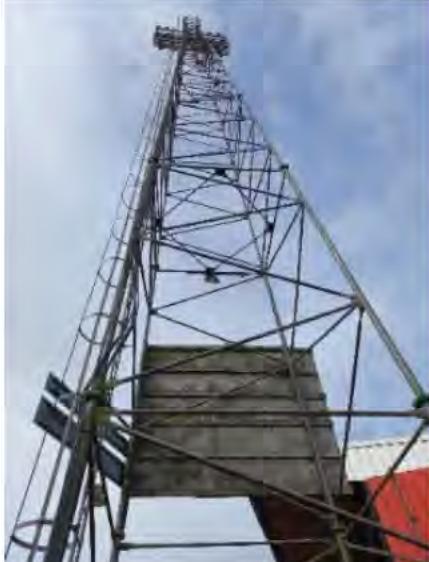
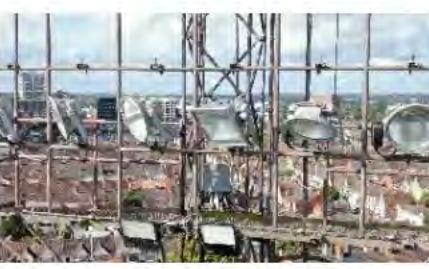
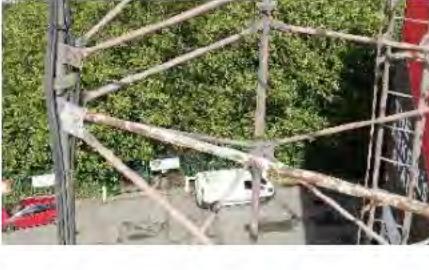
<p>The floodlight towers show no signs of distress, such as bowing or inclination.</p> <p>The galvanised steelwork exterior appears to have a red primer layer overcoated with a zinc rich paint. Both the primer and overcoat paint have been partially worn off.</p> <p>The galvanised steelwork is directly exposed to the elements and widespread light corrosion can be seen on steel members and around welds. Some surface swelling can also be seen.</p>	<p>The condition of one of the floodlights was assessed in detail in October 2021 and the results and recommendations presented in Ramboll report 1620012351-RAM-XX-2021-S-R03.</p> <p>The report recommends that to prevent deterioration in the longer term the external surfaces are protected with a painting system to aid the galvanising, which is likely to be near the end of its service life. The report recommends that the internal checks should be undertaken on another tower in the 2024 Annual Inspection.</p> <p>Even though the risk to the stability of the towers in the short-term is considered as low, the flood light towers are likely to be working beyond their original design life (typically 50-60 years). With internal corrosion present which will potentially degenerate further the replacement of the floodlights should be considered during any potential redevelopment or upgrades to the stadium.</p>

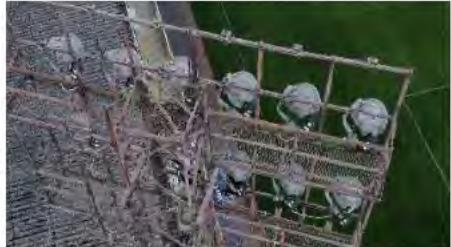
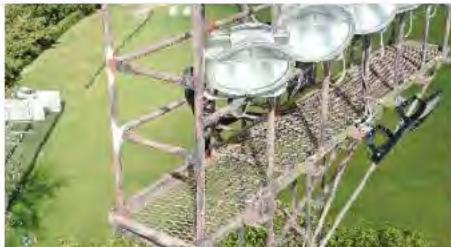
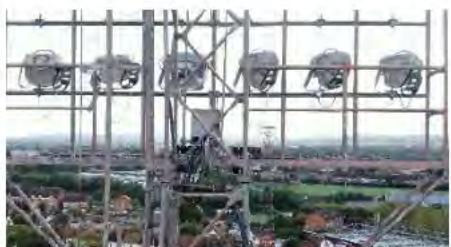
Secondary cables are fixed to floodlights seen by Ramboll on towers.	Inspect periodically checking condition.

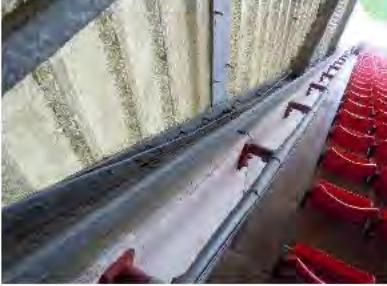
Some fixing plates are corroded. Bolts are corroded.	Refer to Appendix 3 a).
All Barriers

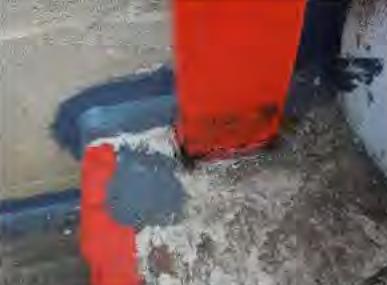
Minor corrosion to base of barrier – due to being unpainted.	Refer to Appendix 3 a).

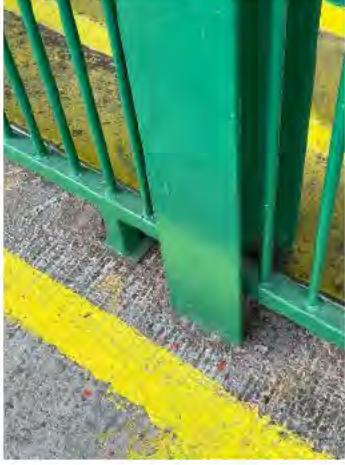
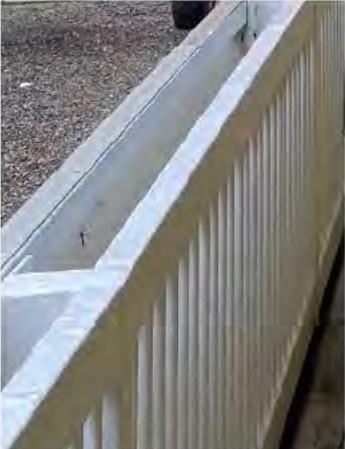
Barriers re-painted.	Refer to section 2.2 Refer to Appendix 3 a).

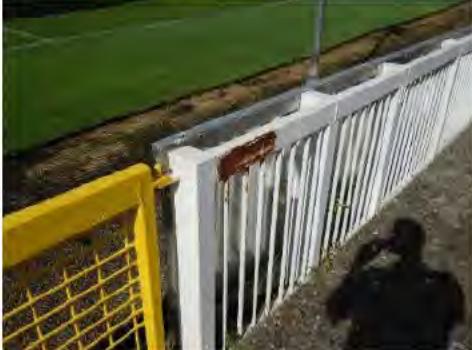
Barriers re-painted.	Refer to section 2.2 Refer to Appendix 3 a).
Rear Barriers to Stand

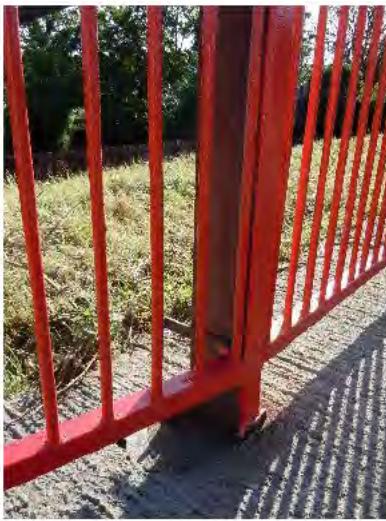
Front side of barriers only are re-painted.	Refer to section 2.2 Refer to Appendix 3 a). Refer to section 7

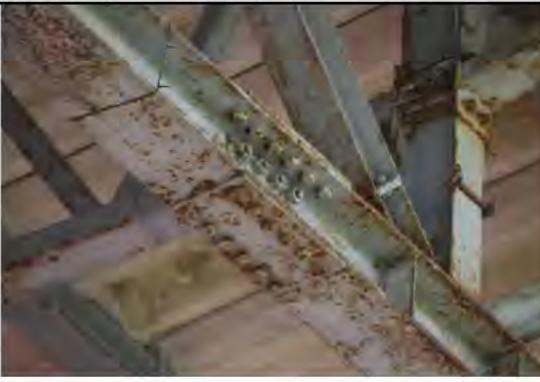
Ramboll Structural Survey: 24 June 2025							
Ref (Ramboll)	Risk	Stand	Location	Photo	Observation	Recommendation	Action Plan
A1 (R009)	High	Arkell's	Roof Steelwork

Widespread corrosion to steelwork with degree of rusting Ri 5 in accordance with ISO 4628. Some localised surface swelling.	Any loose corrosion should be removed and treated to avoid any further corrosion and repainted.	All steel to be prepared and repainted within 3 years.
A2 (R020)	Low	Arkell's	All Roofing

As noted in Appendix 1, Ramboll recommend that the roof steelwork of Town End Stand and Arkells Stand are both properly prepared and repainted. Given the worse condition of the steel to Town End Stand, repainting this roof should be higher priority. We would recommend that it is planned to repaint both roofs within 3 years of the issue date of this report. Also refer to Appendix 3 for further details of methodology.

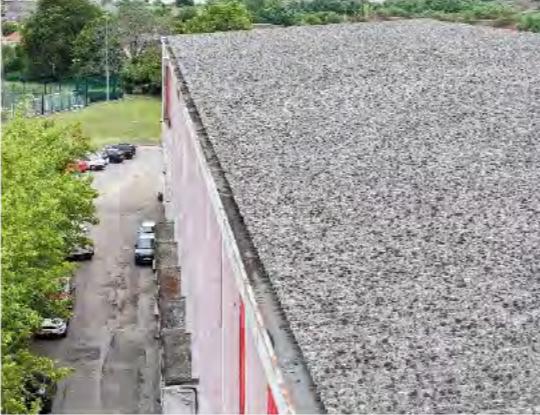
Asbestos roof and fascia. There is evidence of damp areas towards the top of the Arkell's terraces, which is likely to be from leaks in the roof panels. Given the age of the roof and the failed J-bolts connections noted above (Defect 2025-A23), it may be that the panels are near the end of their serviceable life.	For any works involving the roof, seek advice from asbestos specialist, undertake an asbestos condition inspection to determine risk associated.	Full survey & risk assessment conducted circa 2005 last reviewed 2019.

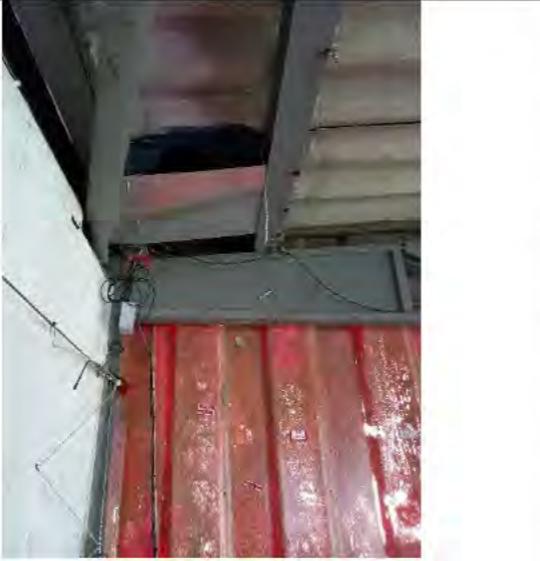
A4 (R001)	N/A	Arkell's	Bowl: V1 back row

<p><del>Waterproof collar around top of flue is broken and visibly see water travelling down flue.</del></p> <p><del>Water is pending on top terrace and penetrating the concourse via the sealant at the terrace/wall interface.</del></p> <p><u>2025 Update</u> Flue removed and roof patched. Sealant between terrace and precast upstand appears in good condition. Only one cracked sealant location (on terrace step) observed.</p>	<p><del>Replace waterproof collar and ensure watertight.</del></p> <p><del>Inspect sealant and replace where cracked/brittle.</del></p> <p><del>Clean terraces/raker to remove algae.</del></p> <p><u>2025 Update</u> Terrace raker cleaning assigned to new defect 2025-A18</p>	No further action required.

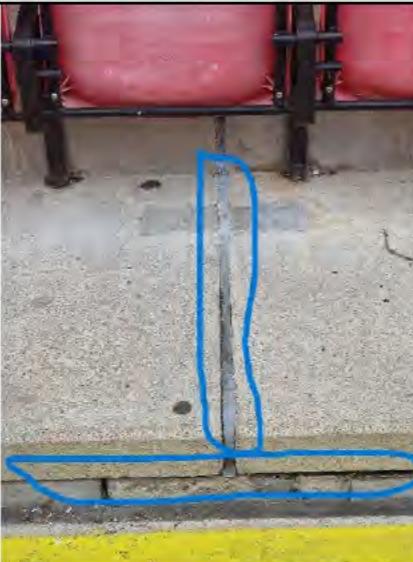
Ramboll Structural Survey: 24 June 2025							
Ref (Ramboll)	Risk	Stand	Location	Photo	Observation	Recommendation	Action Plan
A5	Low	Arkell's	Bowl: Front Row

Sealant is brittle and cracked.	Sealant should be replaced.	
A6	Low	Arkell's	DIY Store in Lower Terrace

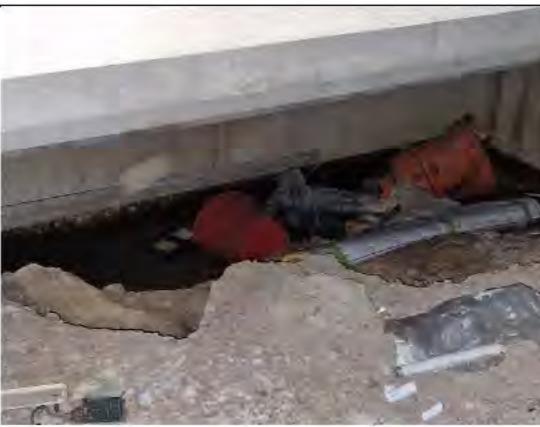
Water visible at base of raker likely to be driven by previous defect (A5).	Likely caused through brittle sealant and ingress of water.  Water should be removed immediately and monitored to ensure no ponding can occur.	Continue to monitor and use pump to ensure no ponding occurs.
A7	Low	Arkell's	Lower concourse: Kitchen Prep & Store Areas

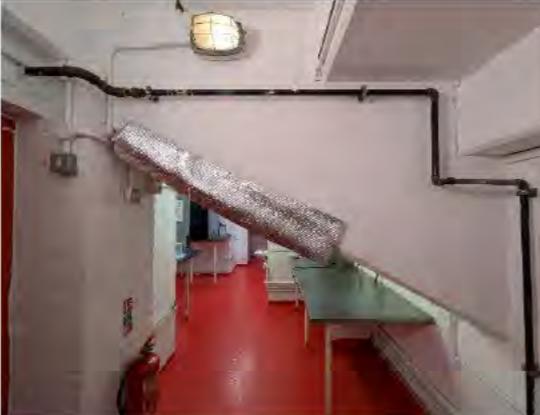
2023 inspection noted that rust had been cleaned off and sealant applied.  No defects were noted during the 2023 or 2025 Inspections.	No further action.	Area should continue to be monitored by club for further water ingress, and any structural concern noted in next year's Annual Inspection.

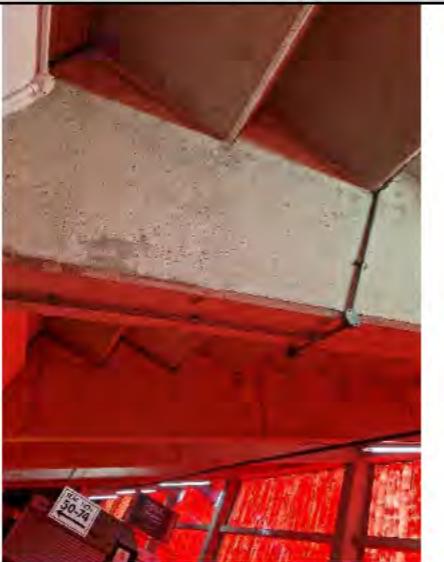
Ramboll Structural Survey: 24 June 2025							
Ref (Ramboll)	Risk	Stand	Location	Photo	Observation	Recommendation	Action Plan
A8	Low	Arkell's	L2: Upper concourse

Superficial cracks along concrete encasement to steel beam.	Likely a shrinkage crack from the time of construction. Size of crack in 2025 inspection does not appear to have increased from 2023 inspection.	No action required.
A9	Low	Arkell's	L2: Upper concourse

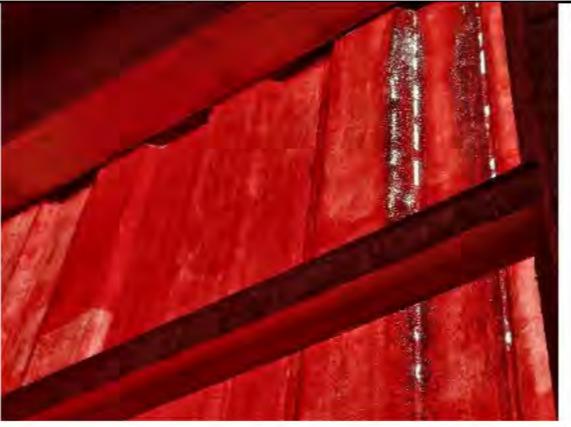
Minor corrosion to steel beam widespread throughout Concourse	Any loose corrosion should be removed and treated to avoid any further corrosion and repainted.	
A11 (R010)	High	Arkell's	L2: Upper concourse

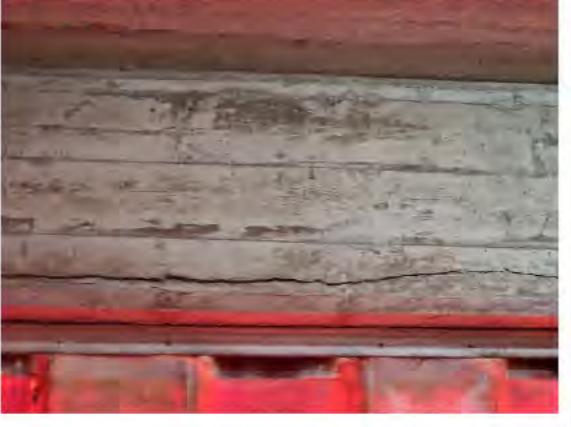
Crack (about 8mm wide) along base of concrete encasement to steel beam. Cause and age unknown.	Removing delaminated concrete and recasting concrete to ensure cover to embedded steel beam.  Clean steel back to bare metal then paint prior to concrete encasement.  Recommend use of Fosroc Renderoc HB45 or similar material for concrete reinstatement.

- Repair a horizontal crack to the concrete beam in Arkells Stand upper concourse (A11).
- Repair Arkells raking beam with exposed reinforcement (2025-A16)

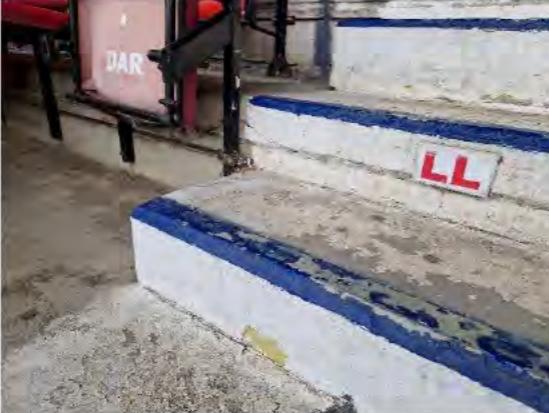
Ramboll Structural Survey: 24 June 2025							
Ref (Ramboll)	Risk	Stand	Location	Photo	Observation	Recommendation	Action Plan
2025-A14	High	Arkell's	Bowl: Row LL (V6)

Seats supports are heavily corroded with degree of rusting Ri 5 in accordance with ISO 4628. There is a crack in the slab extending from the bolt thread.	Urgently replace corroded seat support frames.	
2025-A15	High	Arkell's	Bowl: Row B (Seat 82) and other nearby locations

- Conclude replacement of j-bolts which fix Arkells roof panels (2025-A23).
- Fix Arkells seat fixing observations (2025-A14 & 2025-A15)
- Resolve locally unsupported areas of Town End roof deck adjacent to lighting column tower (2025-T1).

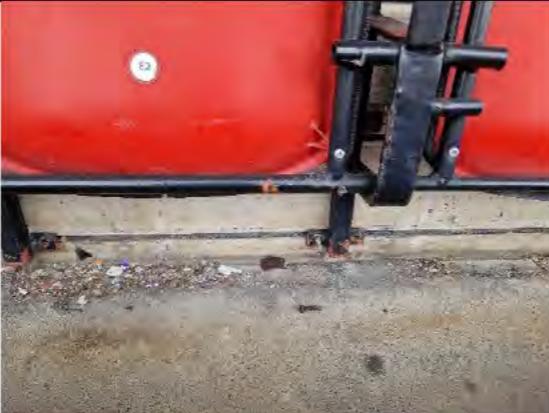
Missing bolts at the seats supports.	Replace missing bolts.	Repair as recommended.
2025-A16	Med	Arkell's	L2: Upper concourse (Near gents toilets at east end)

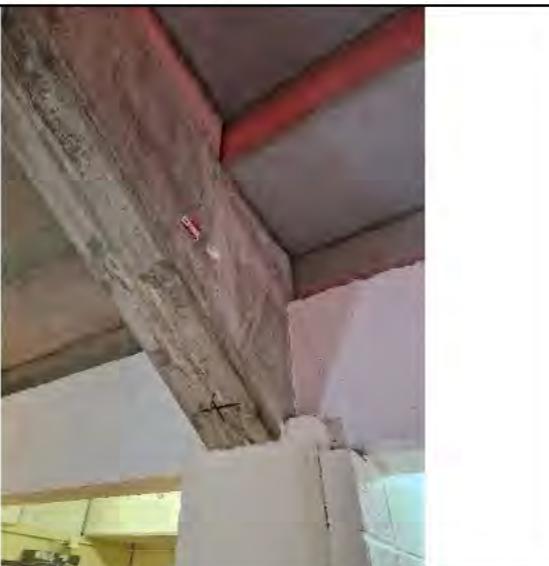
Exposed reinforcement to concrete encasement to steel beam.	Repair so that cover is maintained to reinforcement.	Follow procedure recommended in Appendix 3a.

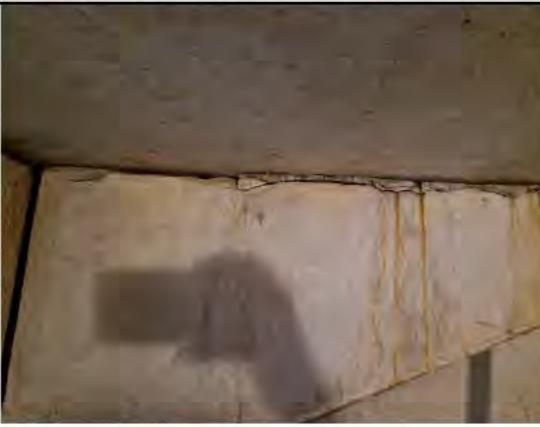
Ramboll Structural Survey: 24 June 2025							
Ref (Ramboll)	Risk	Stand	Location	Photo	Observation	Recommendation	Action Plan
2025-A17	Low	Arkell's	Maintenance Store

Missing grout.	Replace grout.	
2025-A18	Low	Arkell's	Upper concourse

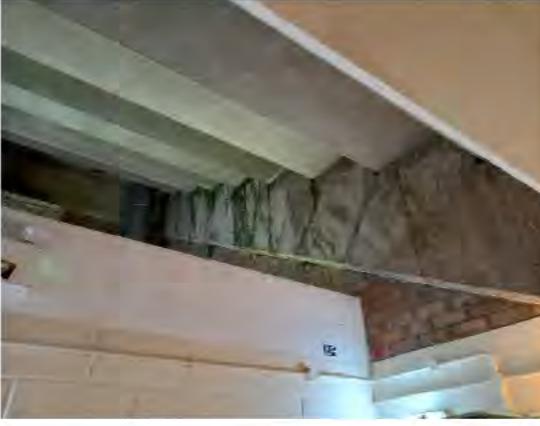
Visible moisture ingress from water penetrating above.	Seal, clean and replace damaged sealant above.  Clean all algae/green mould from side of raker.  Area should be monitored for further water ingress and other potential structural damage.	
2025-A19	Low	Arkell's	Laundry Room

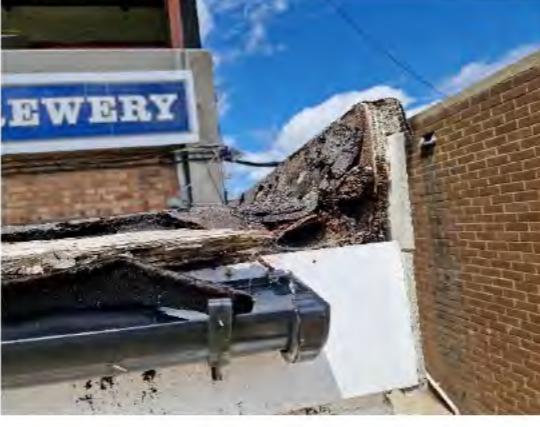
Damaged laundry room roof including rotten timber.	Replace roof to prevent further damage to structure.

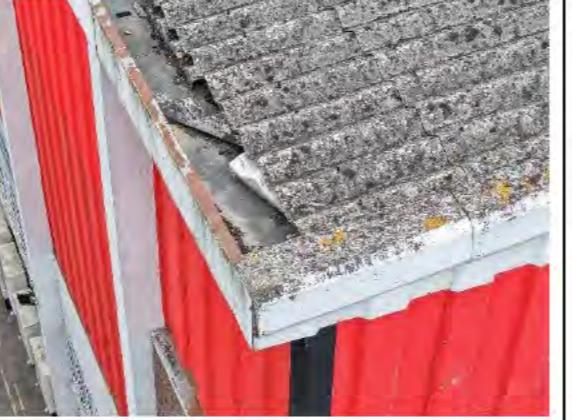
Ramboll Structural Survey: 24 June 2025							
Ref (Ramboll)	Risk	Stand	Location	Photo	Observation	Recommendation	Action Plan
2025-A20	Low	Arkell's	Roof

Displaced roof sheeting support.	Put support back in place.	
2025-A21	Low	Arkell's	Executive and Hospitality Suites roof

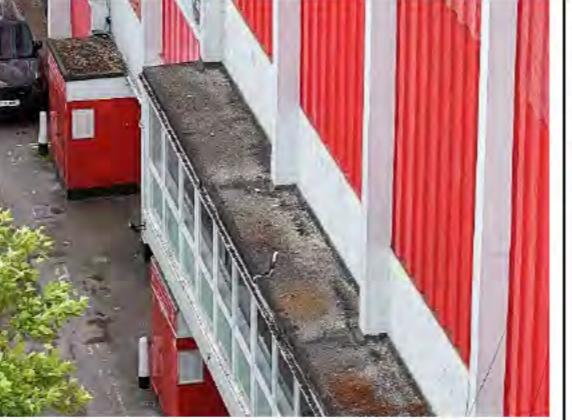
Roof felt appears in poor condition. Loose flashing/edging visible in places. Gutters not clear.	Gutters should be cleaned with all debris and any plant life removed. Loose flashing to be repaired.	Plan to replace roof felt in next 5 years.
2025-A22	Low	Arkell's	External façade

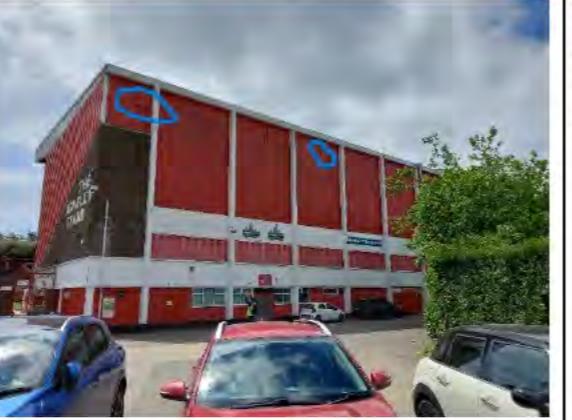
Opening in façade cladding panels in at least 2 different locations. This defect was also recorded in 2023 Report.	Replace damaged façade panels to prevent water entering internal building and corroding elements.

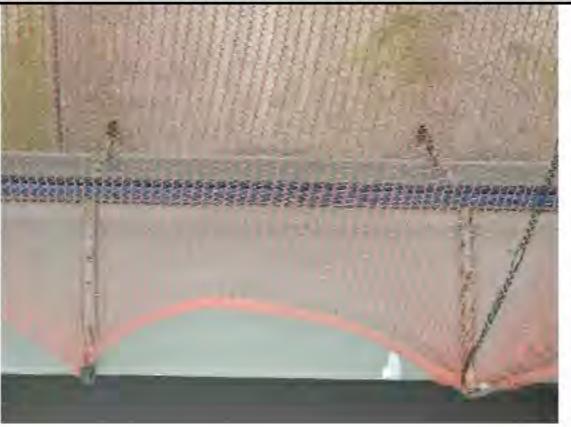
Ramboll Structural Survey: 24 June 2025							
Ref (Ramboll)	Risk	Stand	Location	Photo	Observation	Recommendation	Action Plan
2025-A23	High	Arkell's	All Roofing Connection Points except in bays 1-3 + 4 more bays done. 11 left remaining.

<p>It was reported to Ramboll that a number of J-bolts, which connect the roof panels to the steel beams, have corroded from the top and fallen through the panel. The bolts have been caught by the netting below the roof.</p> <p>Since inspection in 2022 the County Ground have replaced J-bolts in 7 bays. J-bolts in remaining 11 bays remain.</p> <p>The bolts appear in some locations to be causing damage to the paint system on tightening.</p>	<p>The loss of these bolts is a safety concern, as the bolts themselves risk injuring those below or could release an entire panel from its fixing causing it to blow or slide off. This represents a serious safety risk to stadium users and members of the public.</p> <p><b>It is strongly recommended that the club take urgent action to make this entire area safe.</b></p> <p>Courses of action include: replacement of the roof panels and connections, testing and repair of the fixings, or inspecting the locations of the intact J-bolts to ensure that all panels have sufficient intact connections.</p>

- Replacement of a number of J-bolts connecting the roof panels to steel beams.

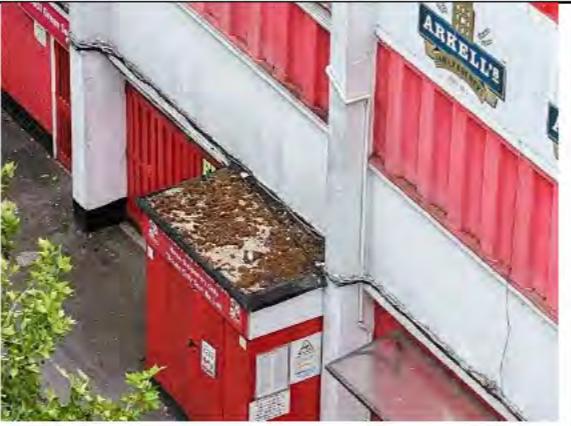
2025-A24	Low	Arkell's	Turnstiles Access Roof

Roof North edge of Arkell's appears in poor condition.	Roof should be cleaned and any plant life removed.	Plan to replace roof felt in next 5 years.
2025-A25	Med	Arkell's	Southwest Storage Room

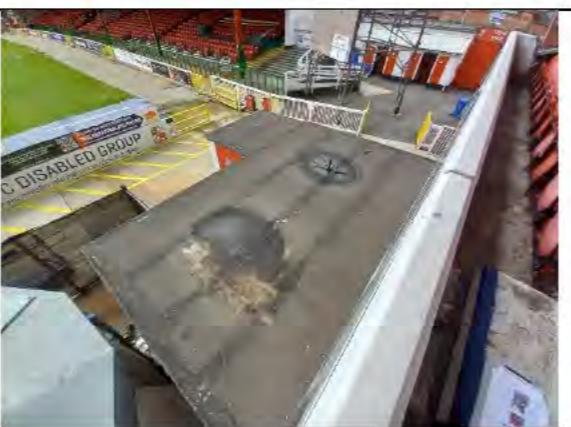
<p>By eye, timber roof joists appeared undersized based on their centres and span. Simple preliminary analysis suggests that they are undersized for their design loads.</p> <p>Roof can be accessed and is likely to collapse if loaded.</p> <p>Clear that roof does not properly drain. This will be a source of problems in the future.</p>	Plan to replace roof structure within next 2 years.

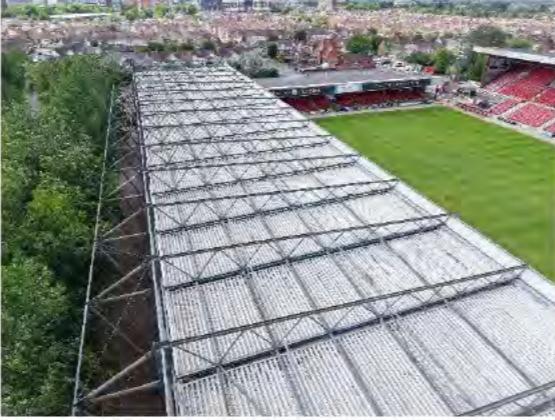
Ramboll Structural Survey: 24 June 2025							
Ref (Ramboll)	Risk	Stand	Location	Photo	Observation	Recommendation	Action Plan
D1	Low	Don Rogers	Entire Roof

<p>Minor corrosion to truss steelwork and bracing.</p> <p>Some debris can be seen in the drainage channels.</p>	<p>No structural concerns to the frame, this is an aesthetic issue only. Any loose corrosion should be removed and treated to avoid any further corrosion and repainted. Galvanised members should be repainted with an aluminium-based paint. Cleaning the steel is likely to prolong the life of the protective galvanising.</p> <p>The drainage channels should be cleaned with all debris and any plant life removed.</p>	
D3	Low	Don Rogers	Undercroft: void under lower terrace

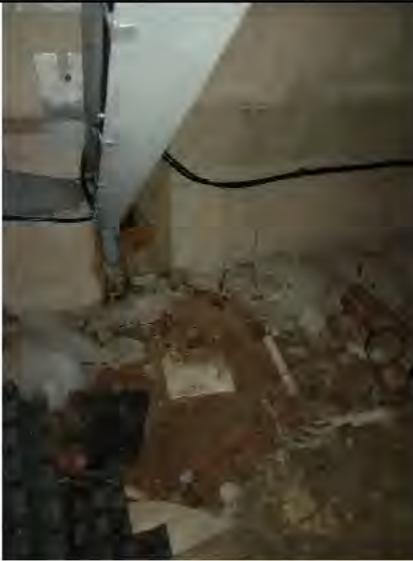
Raker to Foundation Interface: Steelwork was observed.	No comments.	Detail for concrete encasement to rakers being produced as part of Structural Appraisal report.

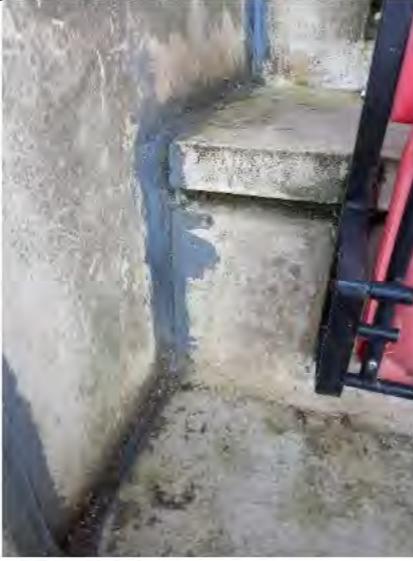
D4	Low	Don Rogers	Bowl: Internal Sides of Stands – Precast Unit Joints

No significant change observed with respect to previous reports.	Unknown if horizontal sealant is required by design. No noticeable water ingress on internal side.

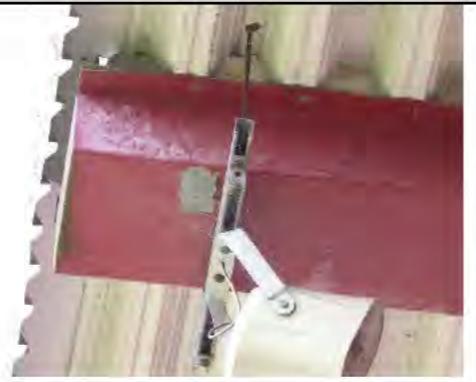
Ramboll Structural Survey: 24 June 2025							
Ref (Ramboll)	Risk	Stand	Location	Photo	Observation	Recommendation	Action Plan
D7	Low	Don Rogers	Roof drainage channel

Flaking paint to drainage channel.	Remove flaking paint and repainted in accordance with a paint manufacturer's specification.	
D11	N/A	Don Rogers	Mezzanine Flooring		Precast planks are installed but no grout between joints or topping screed has been installed.	For any change of use to this area, a fully structural assessment of the stand is recommended.	No further action required
D12	Low	Don Rogers

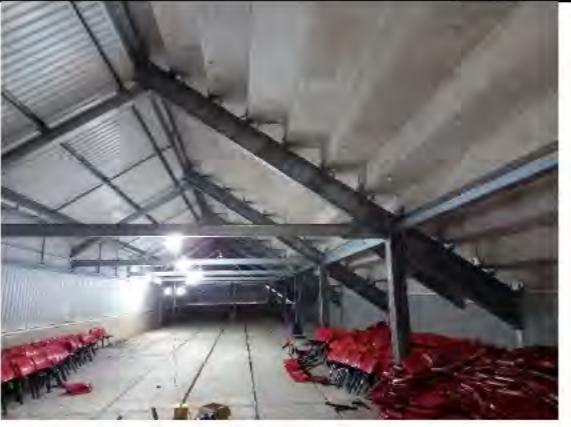
Steelwork is galvanised and in a good condition.		No further action required
D14	Low	Don Rogers	External Perimeter Steelwork

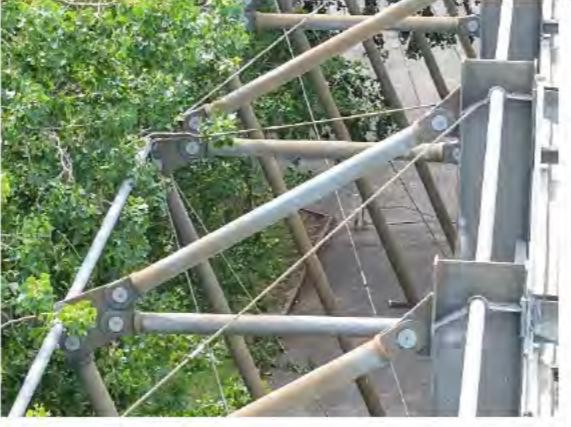
Steelwork is galvanised and in a good condition. Some dust/algae on some elements.	Consider cleaning the structure to remove dust/algae on elements.
