Ramboll Structural Survey: 24 June 2025							
Ref (Ramboll)	Risk	Stand	Location	Photo	Observation	Recommendation	Action Plan
D15	Low	Don Rogers	External walkway

SWINDON TOWN ANNUAL INSPECTION STRUCTURAL RISK ASSESSMENT

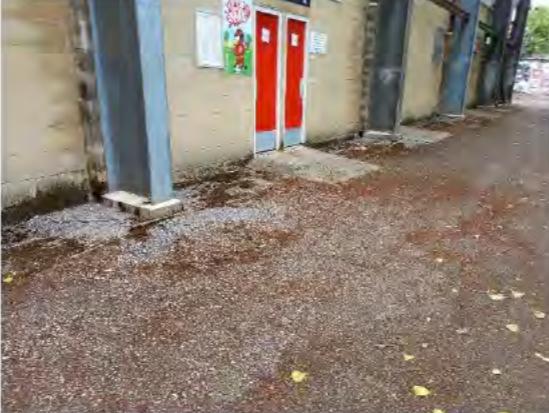
External surface is uneven with some localised cracking.	Likely caused due to differential settlement of the ground compared to foundations. Any cracks should be repaired, but uneven surface is not deemed a trip hazard.	Concrete repairs have been carried out Residual Risk: Low
D16	Low	Don Rogers	All steel column / blockwork wall interface

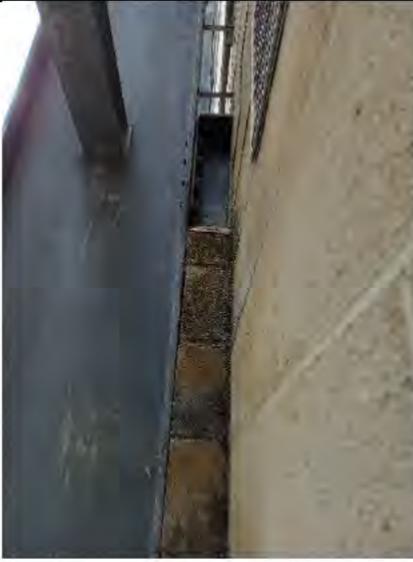
Unusual tie detail between steel columns and blockwork wall, causing localised cracking to blockwork. Staining of blockwork from moisture ingress.	Thermal expansion of steelwork (connected to blockwork with wall ties) is creating cracks. No action required. Staining will likely continue unless further protection to wall is provided (render etc).	
2025-D50	N/A	Don Rogers	External rakers

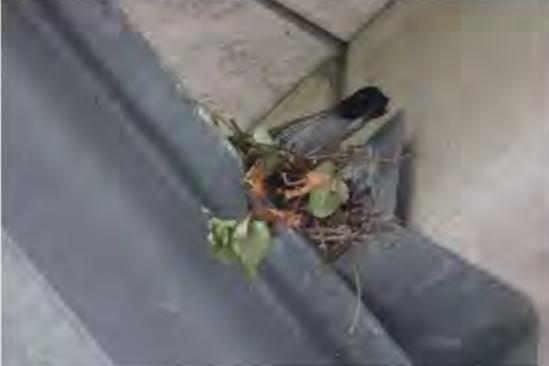
Bird nest on external rakers.	Bird nests cannot be removed if young are present. Consult an environmental specialist.	No further action required.

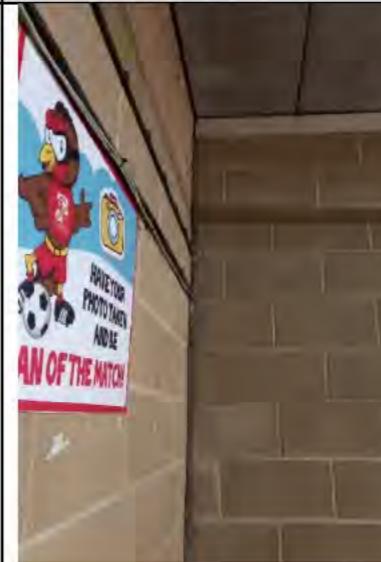
Cracks are present between the turnstile booth walls and the external perimeter wall. Cracks are wider at the top than the bottom. Unclear visually whether concourse slab has deflected or whether perimeter wall has moved outwards. Club have checked with spirit level and believe that perimeter wall is vertical. Ramboll review with spirit level confirmed this and also verified apparent settlement of concourse slab. Walls to one bank of turnstiles have been deconstructed to approx. 1.3m high. Ties noted between perimeter wall and mezzanine slab – suggest that external wall spans vertically and does not rely on return walls for stability.	Deconstruct other turnstile walls to same height as those already deconstructed.	This is also discussed in Structural Appraisal.

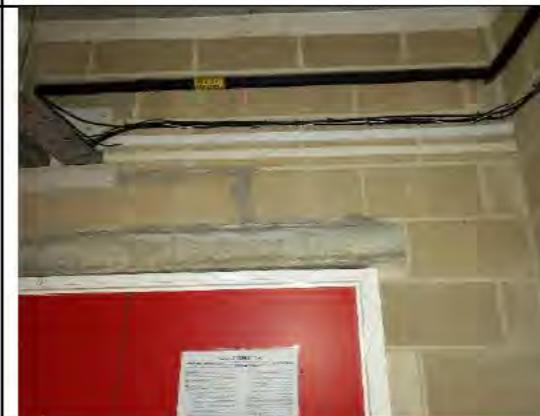
2025-D52	Low	Don Rogers	Lintel and blockwork above double door at west end of concourse.

<p>Large tapering gap between door frame and underside of lintel. Apparent mortar repointing around this area. Some unrepaired cracks in blockwork.</p> <p>Note that there is also a gap between the base of the wall and the ground slab.</p>	<p>Rake out and repoint cracked mortar joints. Fill gap between lintel and door frame with mortar to maintain fire compartment line. Fill gap between wall base and ground slab with mortar.</p>	Monitor for further cracking (including of repointed joints). (This cracking might be due to settlement of the ground slab)

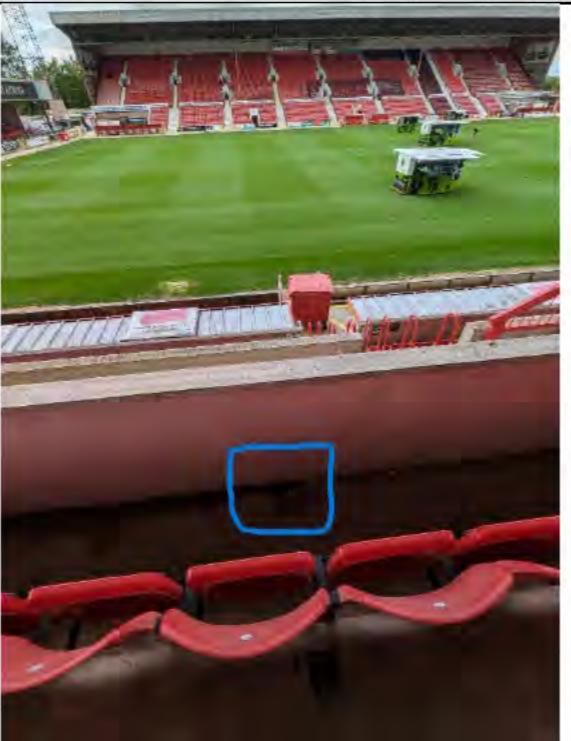
Majority of drainage gullies behind this upstand are partially blocked (photo just illustrates sample location).	Ensure gullies are cleared and downpipes flowing freely. Keeping structures dry is a simple (but important) step in maximising the lifespan of a structure.	
D18	Med	Town End	Roof Steelwork

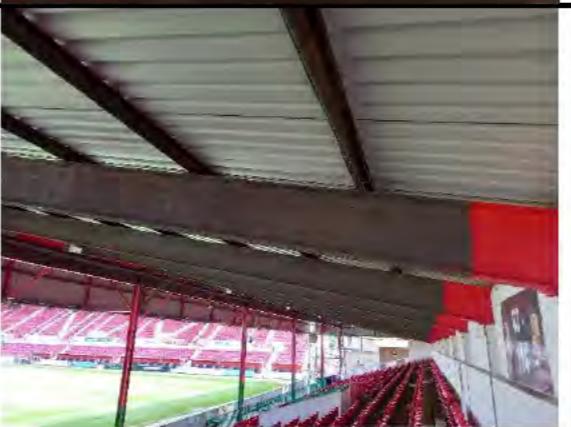
<p>Widespread corrosion with degree of rusting Ri 5 in accordance with ISO 4628 with some larger corrosion patches to steelwork. There is complete breakdown of paint.</p> <p>Repainting works have not been undertaken to parts of the steelwork since last visit.</p>	Any loose corrosion should be removed and treated to avoid any further corrosion and repainted.	All steel to be prepared and repainted within 3 years.

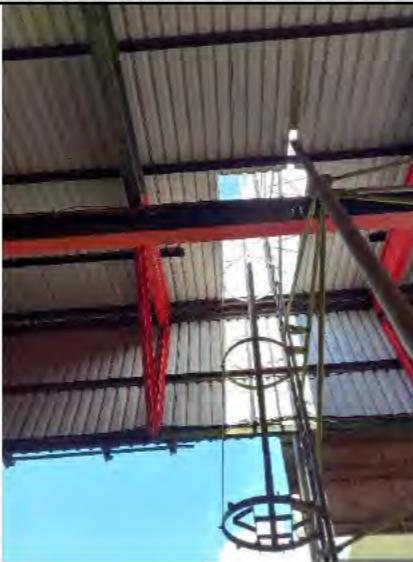
Unsupported areas of roof decking around southwest floodlight tower. There is risk of sudden failure.	Either remove unsupported roof area or replace cut beam with new beam. Urgent action required.	
2025-T2	Med	Town End	Roof

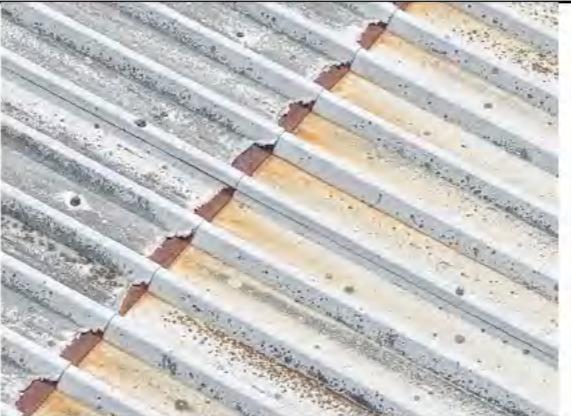
Widespread local failure of roof sheet coating at cut end with clear local corrosion.	Any loose corrosion should be removed and treated to avoid any further corrosion and repainted.	Follow procedure recommended in Appendix 3a.
S1	Low	Stratton Bank					
S2	High	Stratton Bank	Bowl

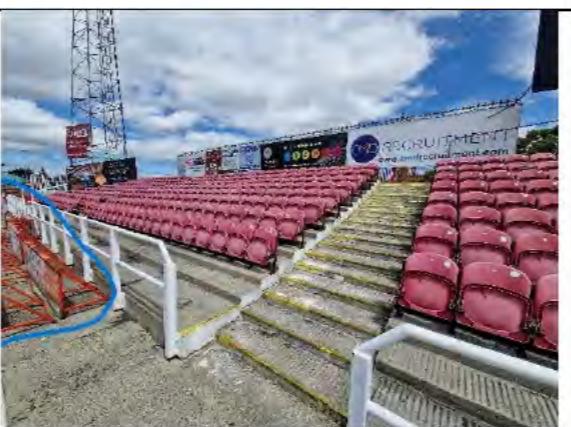
Metal frames blocking gangway and emergency access.	Obstructions should be removed to allow for spectator flow/emergency access to the gangway.

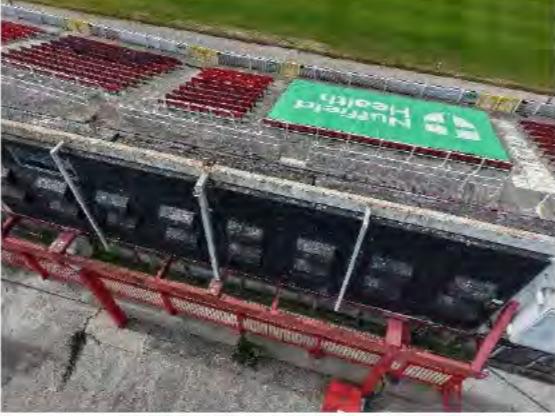
<p>Corrosion to scoreboard structure with degree of rusting Ri 5 in accordance with ISO 4628.</p> <p>Timber sub-structure to scoreboard surround / hoarding is severely rotted. Surround screws visible where timber has rotted away therefore support of surround/hoarding is compromised.</p>	<p>Repaint steelwork.</p> <p>Replace rotted timber sub-structure (note that other timbers may be rotting – to be investigated when top timber is removed).</p>	To be resolved before this part of the stand is reopen.
S6	Low	Stratton Bank	All Joints Across Stand

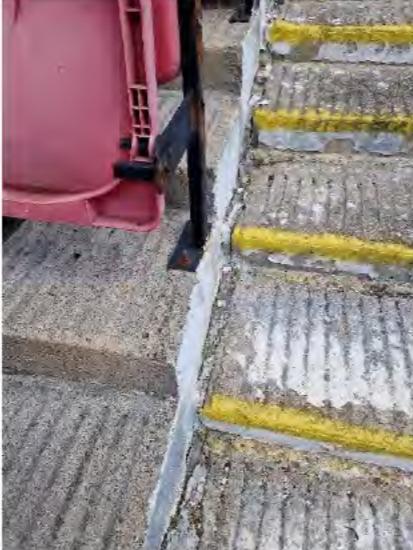
Sealant between terrace unit is brittle and cracked.		Where potential trip hazard may occur, recommended joint is replaced.
S7 (R025)	Med	Stratton Bank	Scaffolding Clock Tower to Rear of Stand

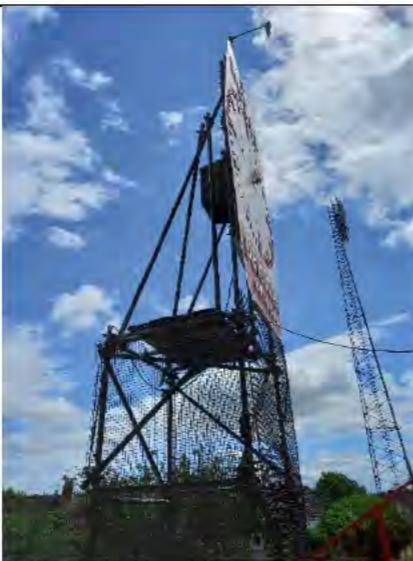
<p>Scaffolding is heavily corroded.</p> <p>No caps to hollow sections therefore corrosion is occurring both externally and internally.</p> <p>Date of erection unknown, historic imagery shows clock tower erected in 1990's. The construction is not appropriate for a permanent external structure – it is likely designed as a temporary structure. No evidence that scaffolding has recently been inspected.</p>	<p>In the short-term, keep up regime of inspecting condition and recording those inspections on 'scafftag'. In medium term the scaffolding tower should be dismantled and replaced with suitable permanent structure.</p>

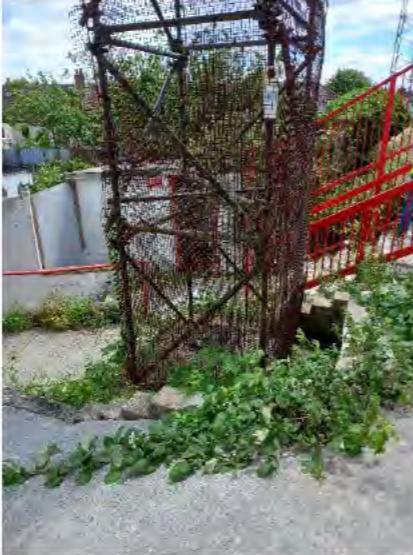
Concrete slab is cracked. Plant life growing in joints & cracks. Individual blocks on wall are loose.	Remove cracked areas of slab and replace. Plant life should be removed to avoid further damage to concrete units. Joint should be sealed. Blockwork should be re-pointed to ensure stability.	All plant life has been removed and concrete repairs carried out. It is understood that this area is not open to spectators. As long as this remains the case, the residual risk is low. Residual Risk: Low
2025-S9	High	Stratton Bank	Toilet Block to the Rear of Stratton Bank

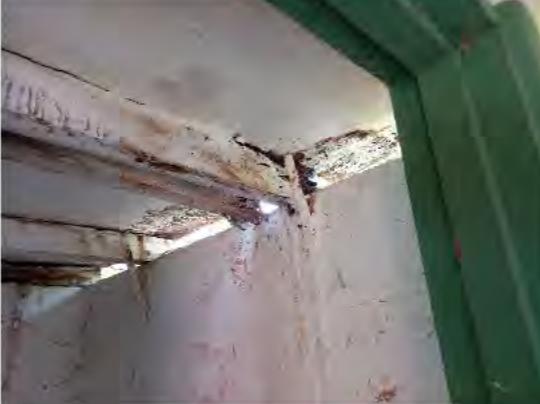
Toilet timber roof beams are heavily rotten.	Deconstruct whole toilet block.	
2025-S10	High	Stratton Bank	Terrace steps

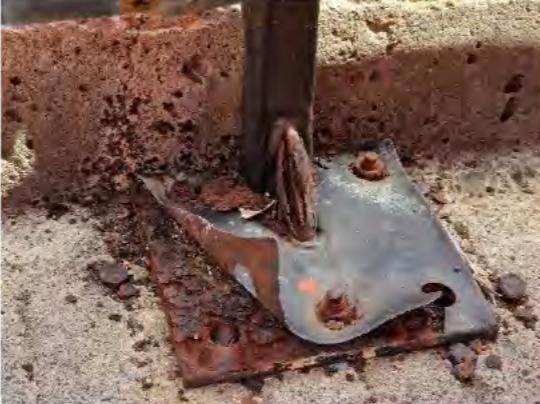
Seating base plates are heavily corroded with degree of rusting Ri 5 in accordance with ISO 4628.	Urgently replace corroded seat support frames.

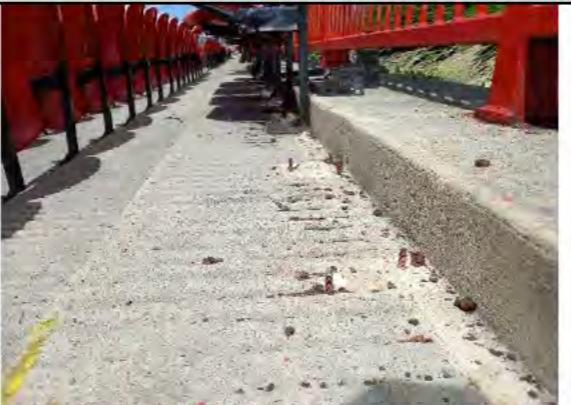
Projecting redundant chair fixing bolts are trip hazard in this area.	Cut out and locally make good concrete surface.	
2025-S12	High	Stratton Bank	Bowl

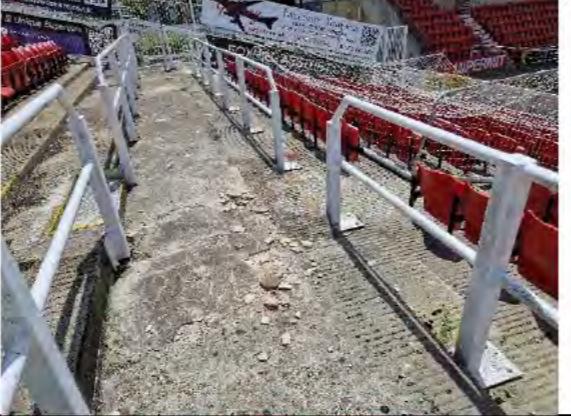
Loose damaged concrete surface.	Repair surface. Loose concrete/screed must be removed in this area.	
2025-S13	High	Stratton Bank	Speaker support posts pitchside by Stratton Stand

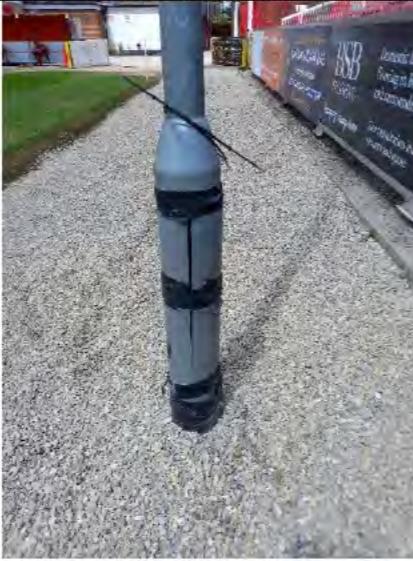
Opening at post North of Stratton Stand. Way for water to leak in to post and corrode steel from the inside out. This may cause undetected serious damage to the post.	Inspect for corrosion inside the post by structural engineer via intrusive inspection. Repair the post such that the door can be closed.

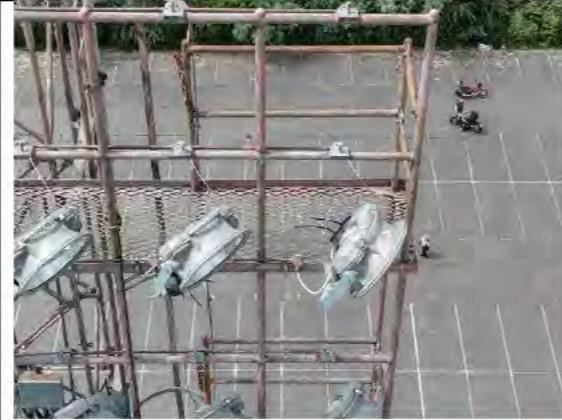
<p>Ramboll understand the lights do not have secondary fixings. Therefore, failure of the primary connection results in the lights falling to ground.</p>	<p>Secondary fixings should be installed immediately to the lighting system.</p> <p>Further inspection is required to ensure all elements (steelwork, grating) are secure and not at risk of failing.</p>	<p>Secondary fixings were installed Summer 2021.</p> <p>No further action.</p> <p>Residual Risk: Low</p>

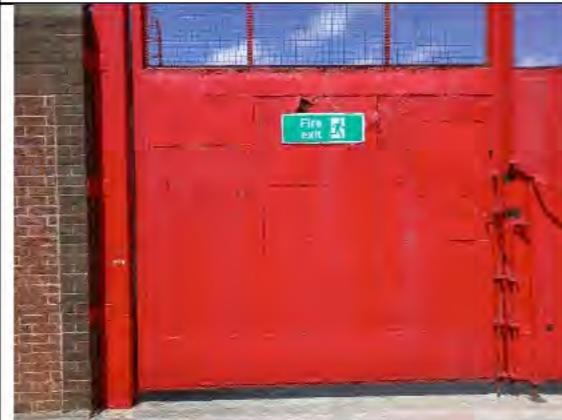
2025-SW1	High		Northwest (E1 and E2) and Northeast Access Gates

<p>The gates are heavily corroded in some locations with degree of rusting Ri 5 in accordance with ISO 4628. Steel sheets are delaminating and can be broken by hand. It is clear that additional sheets have been added – presumably to repair previously corroded panels.</p>	<p>Replace gates. As an alternative, if the underlying frame is still in good condition (without any corrosion or section loss) then it would be acceptable to just replace the sheet panelling. (Note that adding more plate over the existing gates is not acceptable – this will add too much weight to the gates).</p>

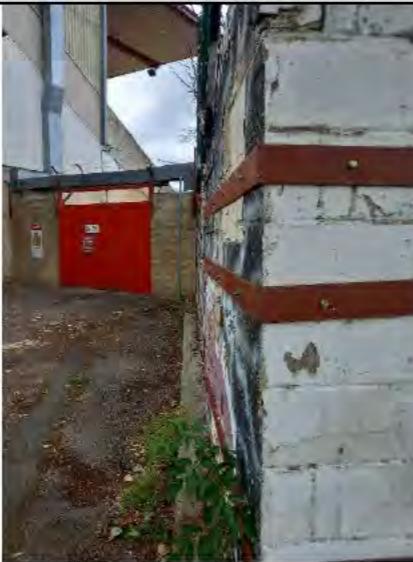
<p>Wall to Southeast corner of the ground has bowed and cracked significantly.</p> <p>Repair works have been undertaken to the wall. In the form of plates/straps and it has been recently repointed in places.</p> <p>It appears that the wall has re-cracked since repointing.</p> <p>Partial local collapse of roofs of ancillary building within area contained by this wall.</p>	<p>The wall is deformed and may not be stable.</p> <p>Repair works are not clearly targeted or designed by a structural engineer.</p> <p>It is recommended that the wall is deconstructed urgently.</p> <p>Until the wall is repaired or replaced, it is recommended that it is propped or an inaccessible zone is created around it to mitigate against collapse and injury.</p> <p>Deconstruct ancillary buildings.</p>

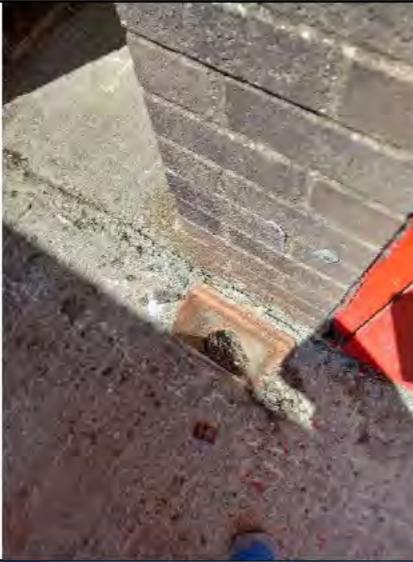
2025-SW3	Low		Northeast Access Gate

Missing drain cover.	Replace missing cover.	
2025-SW4	Low		Northeast Turnstiles Access Room

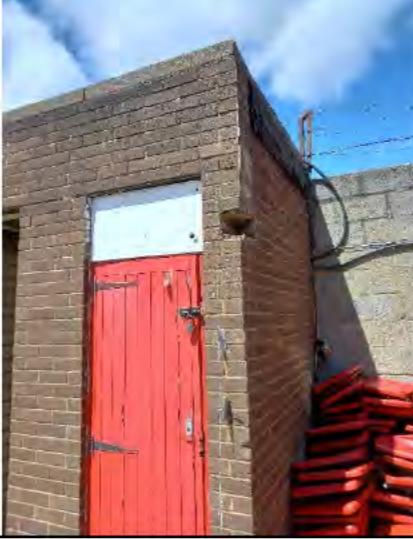
Missing brick in the brick façade.	Replace missing brick.

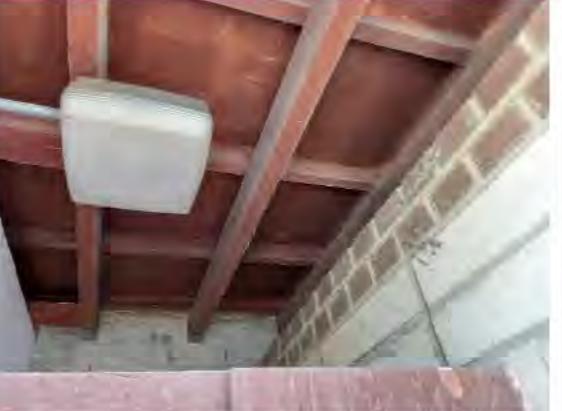
Timber roof of the northeast turnstiles access rooms is in good condition.		No action required.

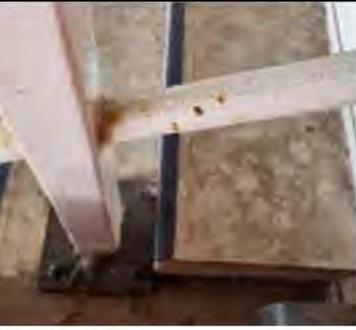
Minor corrosion to barrier.	Flaking paint and any loose corrosion should be removed and treated to avoid any further corrosion and repainted.	Follow procedure recommended in Appendix 3a.
ARA2		Arkell's	Widespread Most Barriers

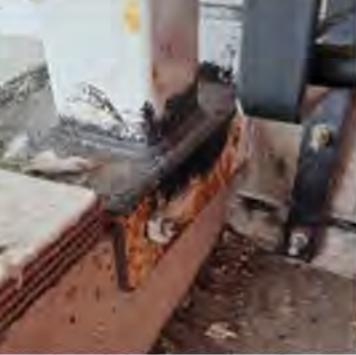
Minor corrosion to barrier	Flaking paint and any loose corrosion should be removed and treated to avoid any further corrosion and repainted.	Follow procedure recommended in Appendix 3a.
ARA3		Arkell's	Side Barriers to Stand

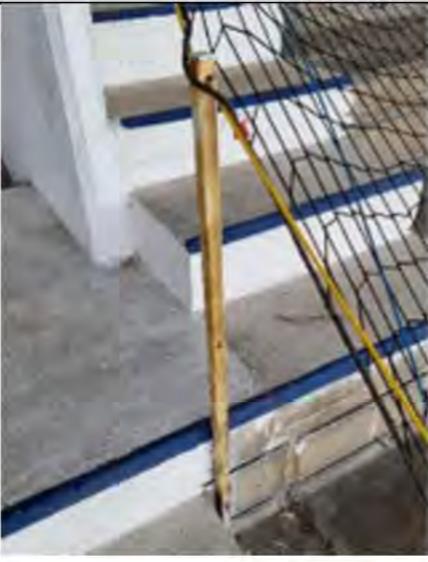
<p>Minor corrosion to barrier.</p> <p><u>2025 Update</u> Barrier no longer present. Netting now supported on seats.</p>	<p>Remove any loose corrosion and apply treat to prevent further corrosion. Apply a proprietary aluminium based paint to the surface.</p> <p>Consider replacement of barriers and netting with alternative barrier system.</p> <p><u>2025 Update</u> Alternative system in use</p>	No further action.
2025-ARA6		Arkell's	Concourse – balustrades around stairs (note that washer plates and bolts are on underside of concourse slab and can be seen from stair landing)

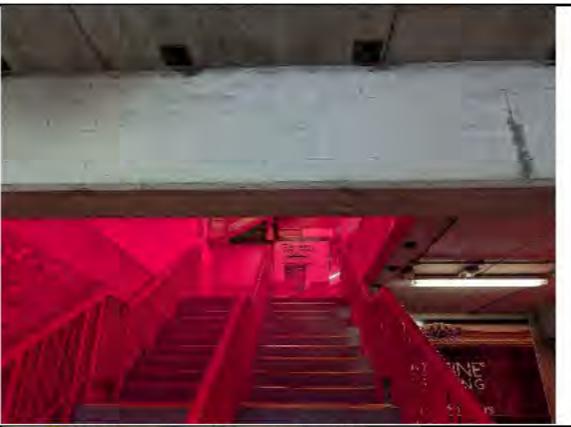
<p>Washer plates to barrier throughbolt appear to be corroded. Lighting not great on staircase – possible that washer plate is just dirty.</p>	<p>Thoroughly clean washer plate. If plate/bolt are corroded then properly prepare and repaint.</p> <p>If plate is simply dirty, recommend repainting with white paint. Any future corrosion will then be easier to identify on future inspections.</p>

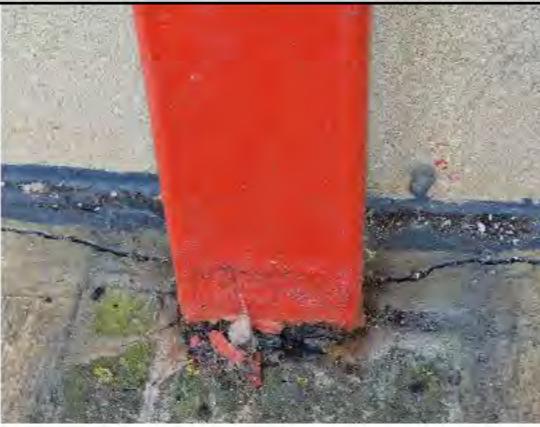
Corrosion at the base of the majority of the uprights with degree of rusting Ri 5 in accordance with ISO 4628. Cracking in the concrete in a number of locations.	Recommend that all barriers to the Don Rogers stand are tested in accordance with Green Guide recommended procedure	Further steps are subject to results of barrier testing.
DRA3		Don Rogers	All Barriers		Localised areas of flaking paint.	Flaking paint and any loose corrosion should be removed and treated to avoid any further corrosion and repainted.	Follow procedure recommended in Appendix 3a.
TRA1		Town End	All Barriers

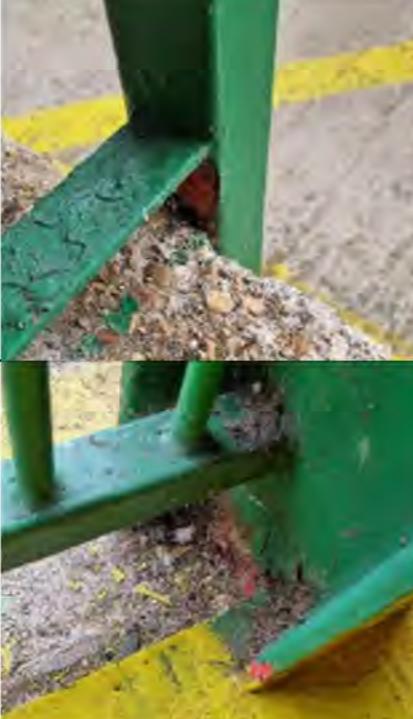
Minor corrosion to base of barrier – due to being unpainted.	Flaking paint and any loose corrosion should be removed and treated to avoid any further corrosion and repainted.	Follow procedure recommended in Appendix 3a.

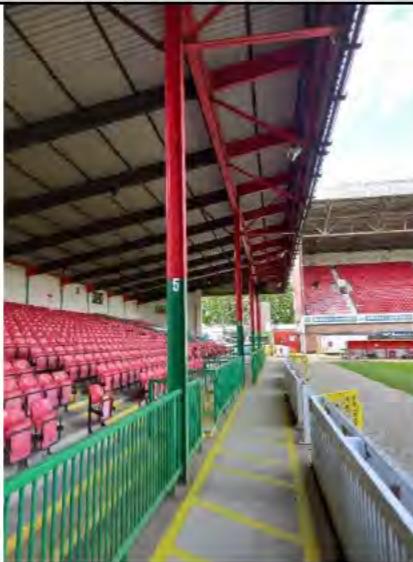
No defects observed but club advised that crowd regularly apply heavy loads to barriers in this area.	It is recommended that the green barriers in front of bottom row of seats and the white pitchside barriers are tested in accordance with Green Guide recommended procedure.	Further steps are subject to results of barrier testing.
SRA1	High	Stratton Bank	All Barriers

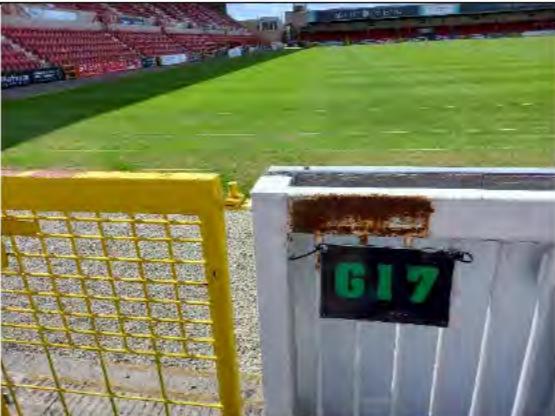
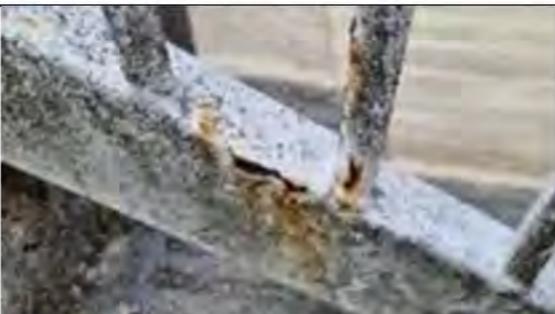
Minor Corrosion to barrier steelwork. Flaking Paint.	Flaking paint and any loose corrosion should be removed and treated to avoid any further corrosion and repainted.	Follow procedure recommended in Appendix 3a.
SRA4	High		White fencing (with yellow gates) to pitchside

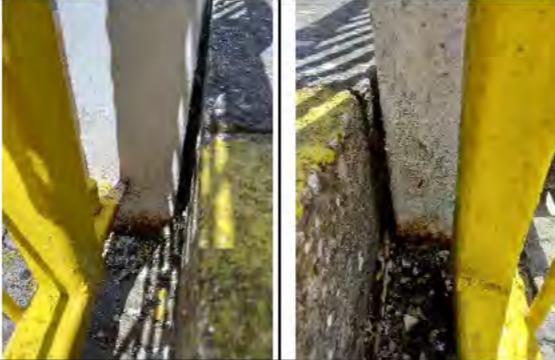
The small gap between the upright and the terrace step is a weakness in that it can fill with debris and moisture. There is some local corrosion at the base of these uprights with degree of rusting Ri 5 in accordance with ISO 4628 and loss of paint at the base.	It is recommended that white pitchside fencing to the Stratton Bank stand are tested in accordance with Green Guide recommended procedure.	Further steps are subject to results of barrier testing.
